## DESTRUCTIVE THUNDERSTORM OVER AMBALA ON 18 MAY 1950

No. 1 Air Force Academy,  
I.A.F. Station,  
Ambala  
December 9, 1950.

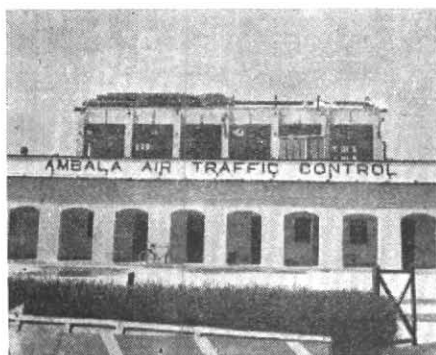
Fig. 2

Flying Control Building (front view). The roof was completely blown off and all the glass panes were shattered. Wind instruments on top of the roof were blown off. The Met. Office is located in the ground floor of this building

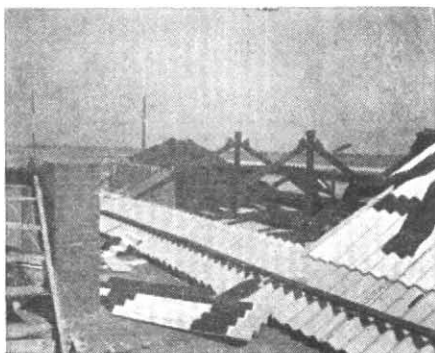
Fig. 3

Roof of Flying Control Building. Large pieces of this roof were picked up from a distance of 200 yards

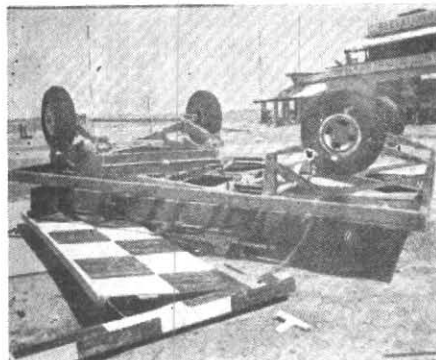
Fig. 4

- (a) The northwestern door of Hangar No. 7 (Fig. 7) which came right in the path of destruction was completely wrenched from its rails, lifted bodily and thrown at a distance of about 250 yards
- (b) A large trolley (Fig 4) weighing about 2 tons was completely lifted off from the ground and thrown about 100 feet away where it landed upside down
- (c) Large pieces from the roof of the Flying Control building were picked up from a distance of 200 yards
- (d) Hailstones broke up practically each and every glass pane facing the wind. The hailstone damage to the rudder of a Liberator aircraft parked in the open is shown in Fig. 13. A large number of birds were also killed by hailstones
- (e) All the iron electric poles on the road outside the Air Force Station were bent down at right-angles from their base. (Photographs not available)

This large trolley was completely lifted off from the ground and thrown about 100 feet away where it landed upside down

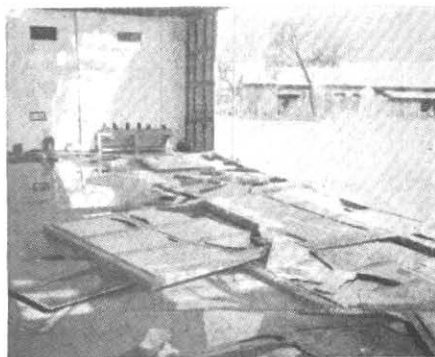
Fig. 5

No. 4 hangar. It was one of the buildings which suffered the maximum damage

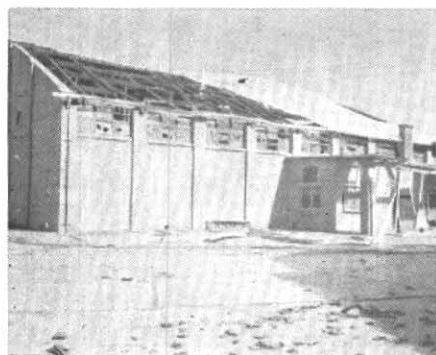
Fig. 6

Side view of No. 4 hangar which suffered major damage. Glass panes shattered by hailstones can be seen

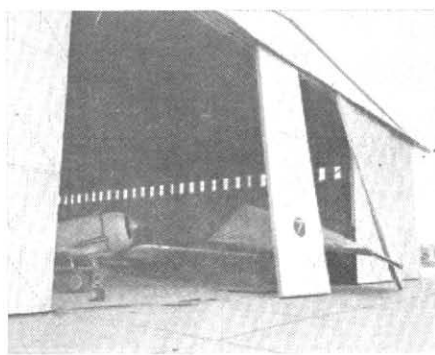
Fig. 7

No. 7 hangar as seen from the northwest. Two door panels were completely wrenched from their rails, lifted bodily and thrown at a distance of about 250 yards

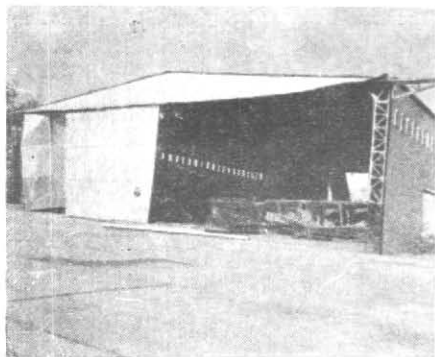
Fig. 8

No. 7 hangar as seen from southeast. The doors were blown off the rails.

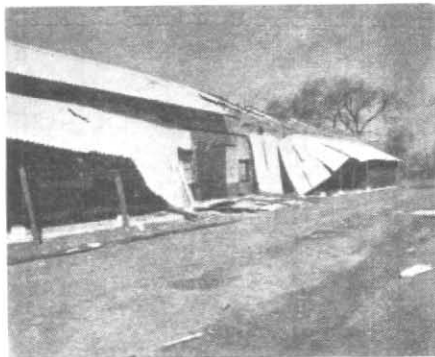
Fig. 9

Workshop Building. It was almost completely wrecked.

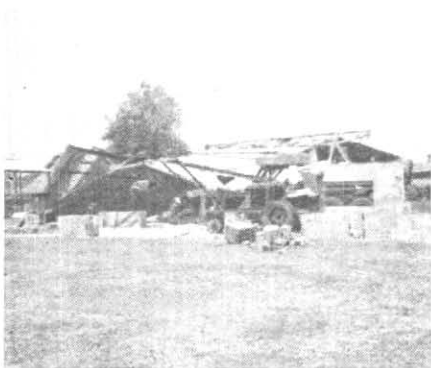
Fig. 10

This newly constructed M. T. shed collapsed completely.

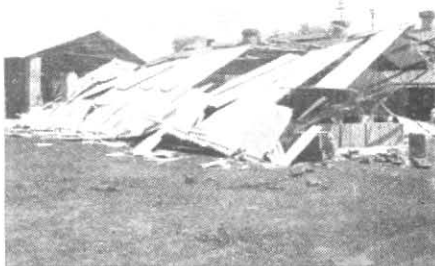
Fig. 11

Another view of the M. T. shed which collapsed completely.

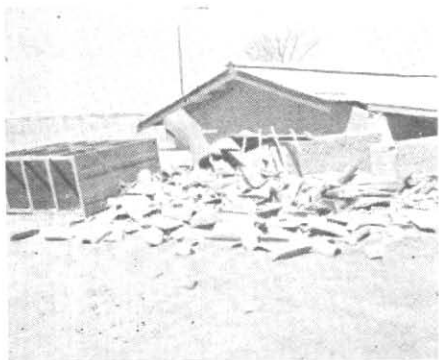
Fig. 12

Entrance to the under-ground lecture room of the Flying Instructors' School

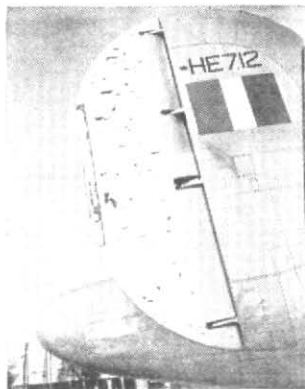
Fig. 13

Damage to one of the twin rudders of a Liberator aircraft due to hailstones. These hailstones were  $1\frac{1}{2}$  inches in diameter
