Mechanisms of riverbank erosion on the Bassac river: Integrating field observations and stability analysis

ABSTRACT. This study investigates the causes of riverbank erosion along the Hau Bassac River in Hoa Lac commune, An Giang province, Vietnamese Mekong Delta (VMD), based on integrating hydrodynamic, sediment, and morphology characteristics. Field data collected in November 2024, representing receding flood season conditions, indicate that high flow velocities, especially on the outer banks of meanders, frequently approached or exceeded calculated permissible non-eroding velocities. Steep bank slopes (> 50 degrees), erodible alluvial materials, and tidal fluctuations further contribute to instability. While regional factors like upstream damming and sand mining exacerbate systemic vulnerability, our findings pinpoint the critical role of local concentrated flow energy and geotechnical weaknesses. The analysis reveals a multi-stage failure mechanism, where extreme velocities during peak floods likely act as the primary trigger for basal scour, while sustained, near-threshold flows during the receding season prevent natural recovery and perpetuate bank instability. This study pro

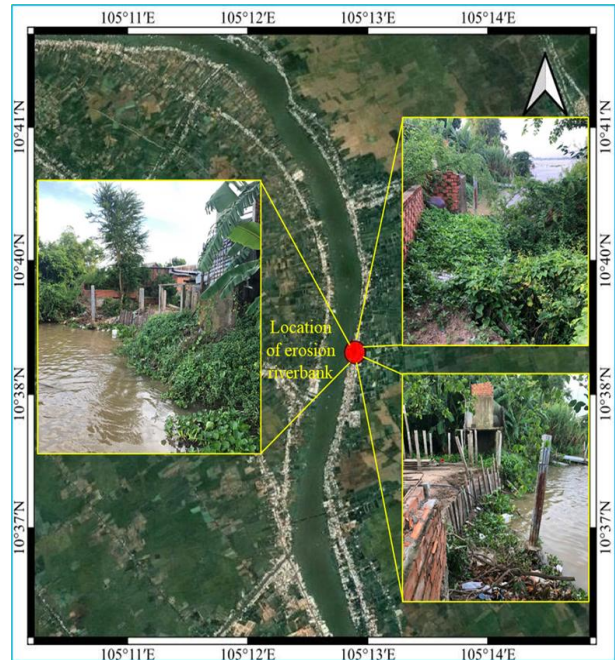
Fig. 1. Map of the study area with location of eroded riverbank on September 23, 2024, in Hoa Lac and Hoa Hung 1 hamlets, Hoa Lac commune, a landslide occurred on the bank of the Bassac River (Source: Google Earth)

The study was conducted along a segment of the Bassac River traversing Hoa Lac commune, Phu Tan district, An Giang province, situated within the upper floodplain of the VMD (Fig. 1). The Hau River, a principal tributary of the Mekong, is a vital water resource for the region. The area is characterized by densely populated riverbanks and intensive agriculture, making local communities highly vulnerable to land loss from riverbank erosion. A significant landslide event on September 23, 2024, at the location corresponding to our cross-section CS3, impacted several households and underscored the urgency of this research. The river reach is influenced by both the seasonal flood pulse of the Mekong and diurnal tidal effects, creating a complex hydrodynamic environment.

Field surveys conducted on November 25, 2024, particularly in the aftermath of the landslide in Hoa Lac commune (Fig.1), confirmed active and significant riverbank erosion within the study reach. Visual evidence included fresh scarps, slumped bank material, and undercutting at the toe of the banks.

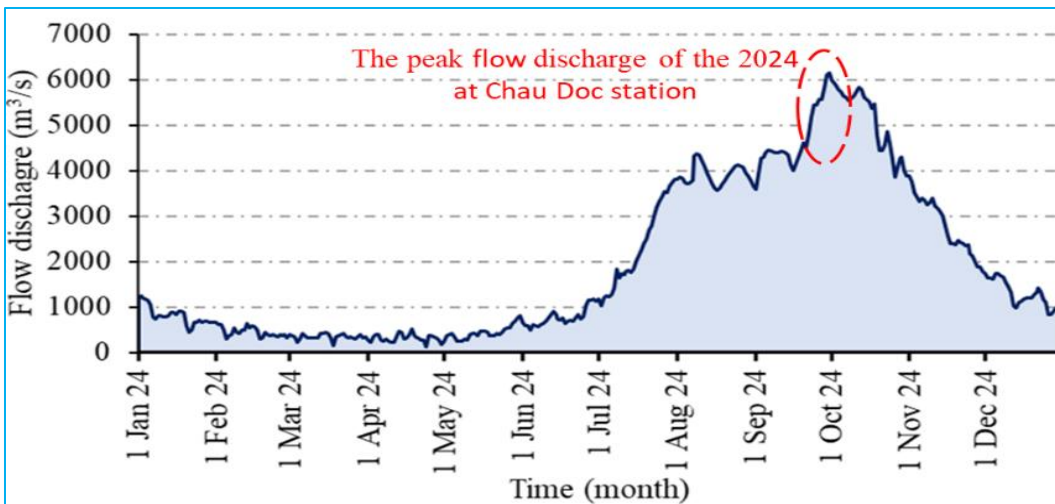
Fig. 4. Distribution of flow discharge across cross section of Bassac River at Chau Doc hydrology station during the flooding season months in 2024

The role of peak flood as a triggering mechanism: The landslide occurred in late September, coinciding with the peak flood period when discharges exceeded 6,000 m³/s (Table 1, Fig. 4). Flow velocities during this peak would have been substantially higher than the 0.68 m/s measured in November, decisively exceeding the non-eroding threshold. This peak flow event likely acted as the primary triggering factor, causing intense basal scour that severely undercut the bank toe and initiated critical instability. Even with the conservative nature of the Neill formula, it is almost certain that peak flood velocities would have overwhelmed the bank's material resistance.
